Manhole Inspection Summary

Manhole # S47MM_034MH

Inspection ☐ Is Incomplete Rating: **3) Fair**

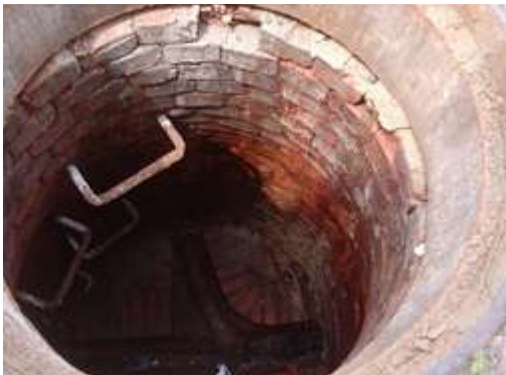
Defect 2

Condition: ☐ Sound ☐ Cracked ☐ Root Intrusion ☒ **Loose Brick** ☒ **Deteriorated**

Deterioration

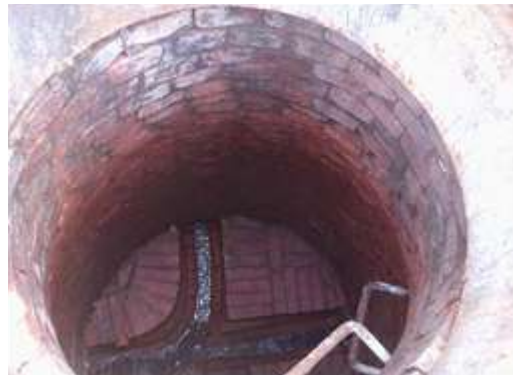
Defect 1

Infiltration: ☐ None ☒ **Joint** ☐ Cracks ☒ **Mortar** ☐ Roots ☐ Wall

Infiltration

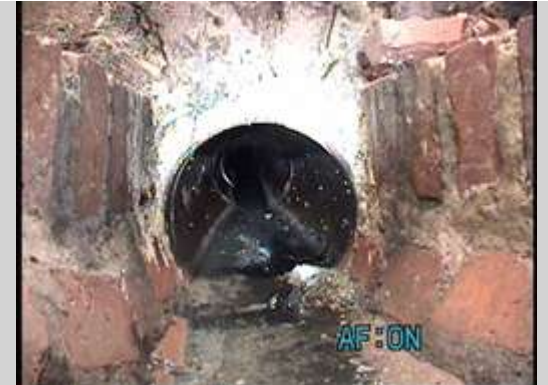
12 O'Clock Outflow

8 in. Circular Gravity Sewer
Pipe Out @ 12 O'Clock

Pipe Height: **8.4** (in.) Rod and Bar (Angled)
Pipe Material: **Clay** ☐ Pipe Lined
Invert Depth: **8.80** (ft.) Flow Characteristics: **Slow**
Deposits: ☒ None ☐ Mud ☐ Sludge ☐ **Debris** ☐ Grease
Silt Depth: (in.) Deposits Extent:
Infiltration: **None** Pipe Seal Cond: **Sound**

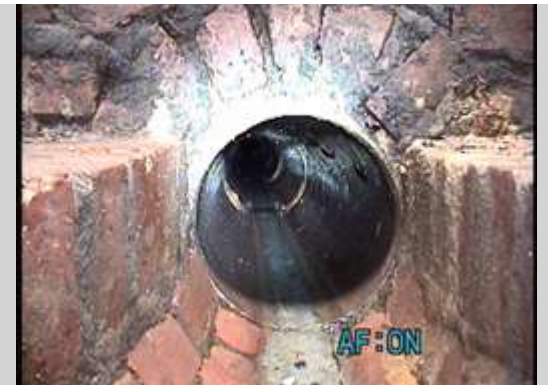
3 O'Clock Inflow

8 in. Circular Gravity Sewer
Pipe In @ 3 O'Clock

Pipe Height: **8.4** (in.) Rod and Bar (Angled)
Pipe Material: **Clay** ☐ Pipe Lined
Invert Depth: **8.60** (ft.) Flow Characteristics: **Slow**
Deposits: ☒ None ☐ Mud ☐ Sludge ☐ **Debris** ☐ Grease
Silt Depth: (in.) Deposits Extent:
Infiltration: **None** Pipe Seal Cond: **Sound**

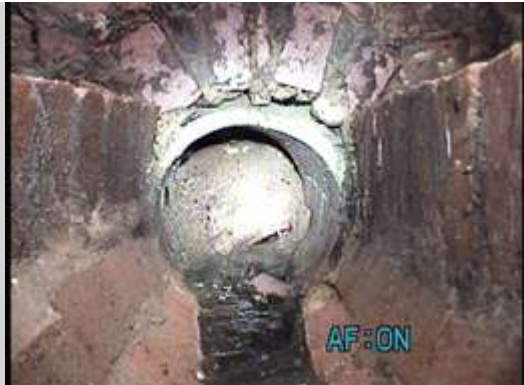
6 O'Clock Inflow

Deposits: ☐ None ☐ Mud ☐ Sludge ☒ **Debris** ☐ Grease

Silt Depth: **7** (in.) Deposits Extent: **Light**

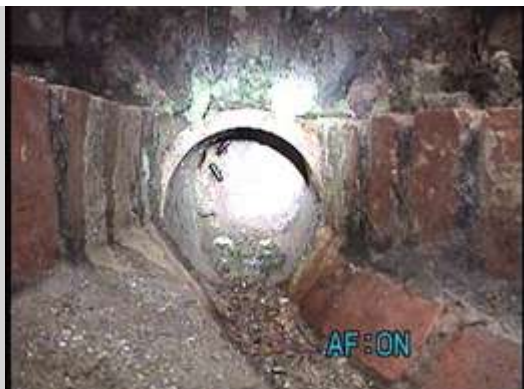
9 O'Clock Inflow

Deposits: ☐ None ☐ Mud ☐ Sludge ☒ **Debris** ☐ Grease

Silt Depth: **5** (in.) Deposits Extent: **Light**
